# DB11

## Recess Mounted Safety Beam

## INSTALLATION INSTRUCTIONS

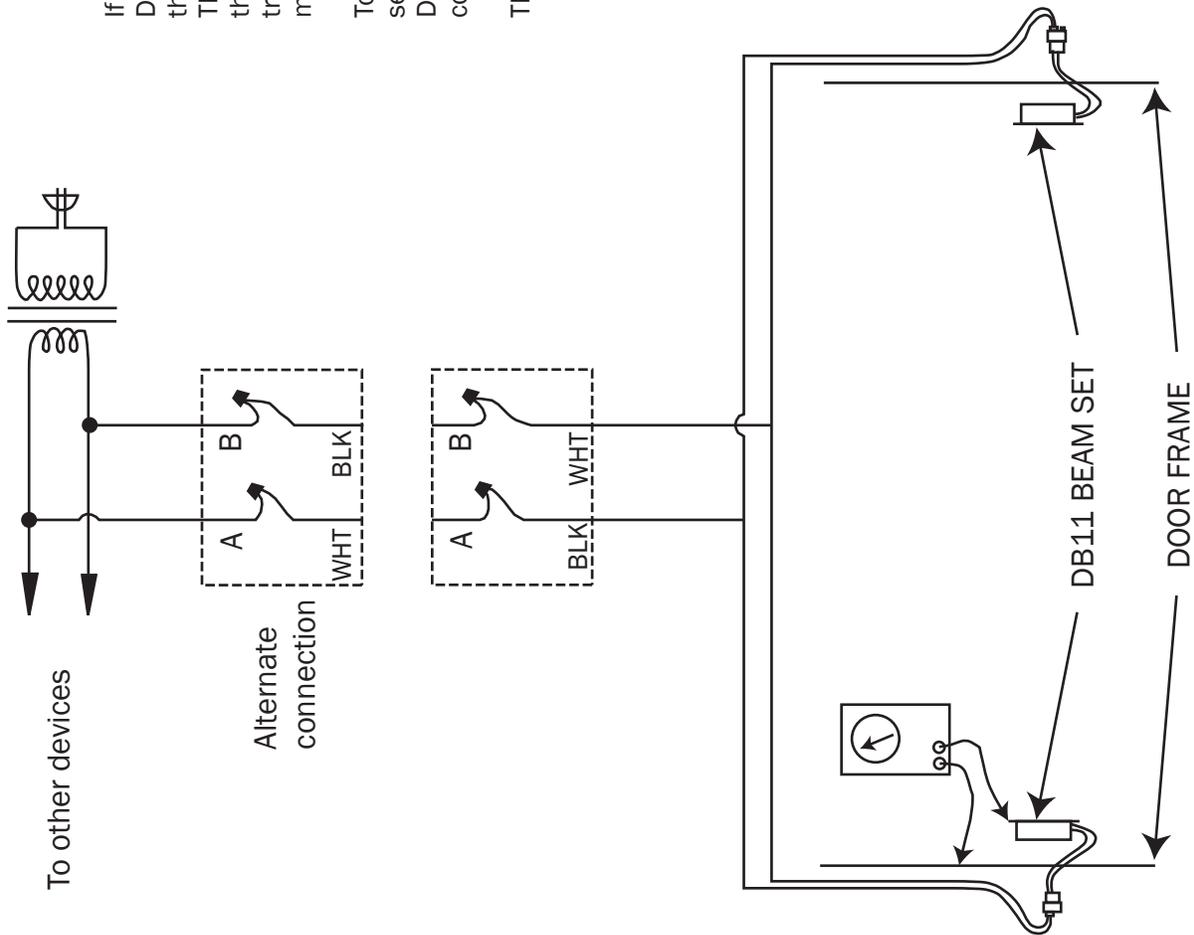
If arcing occurs between the door frame and the DB11 chassis, it is an indication that one side of the secondary of the transformer is grounded. This may occur intentionally or inadvertently through other devices connected to the same transformer. The voltage difference may be measured as shown in the diagram.

To assure proper operation of the DB11 beam set, reverse the power connections to both the DB11 transmitter and receiver. When connected correctly, no voltage will be measured.

The diagram depicts both connection methods.
